TRANSPORTATION RESEARCH CENTER

ON-SITE SCHOOL BUS INVESTIGATION

CASE NO. - 92-10
FLEET - PRIVATE VEHICLE
LOCATION ACCIDENT DATE - 1992

TRC/IU CASE NO. 92-10

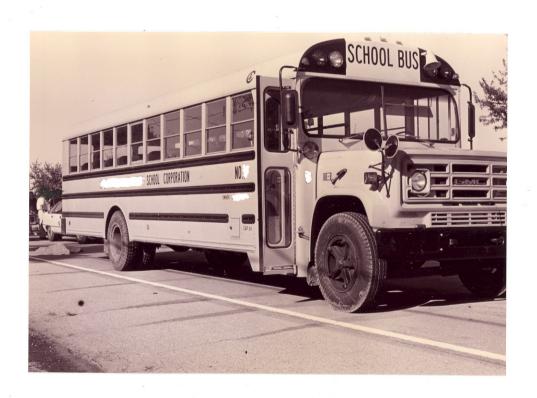
02 -- }

TRC/IU: 92-10, Task: 0085 MCSD-Front & right & victim

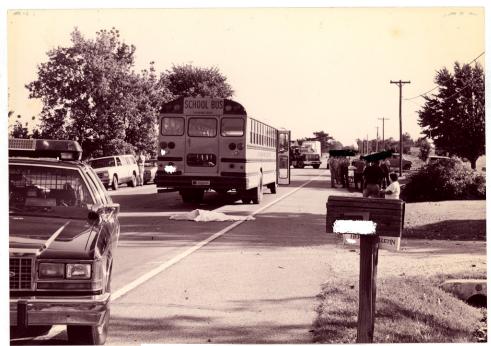
03 --

TRC/IU: 92-10, Task: 0085 MCSD-Rear & right & victim

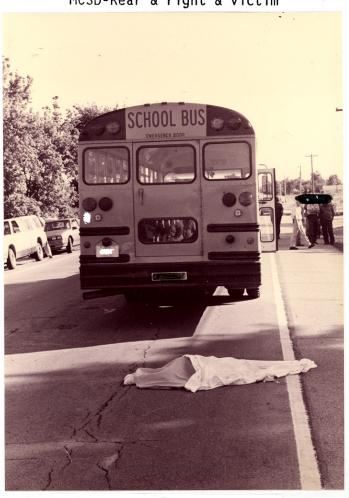
04 --

TRC/IU: 92-10, Task: 0085 MCSD-Rear & victim & R tires

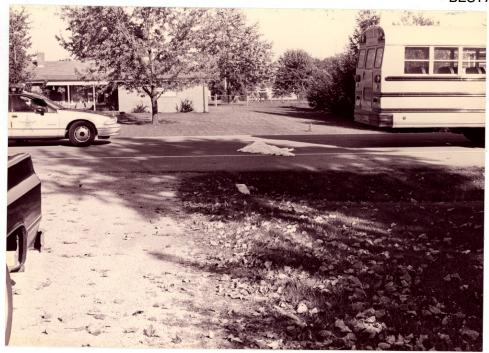
05 -- 1992

TRC/IU: 92-10, Task: 0085 MCSD-Ped's path of travel

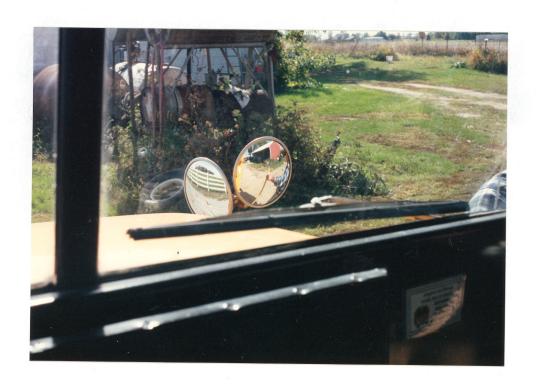
31 --

TRC/IU: 92-10, Task: 0085 Cone K is not visible

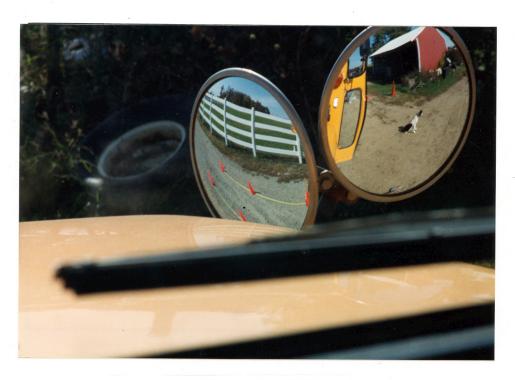
32 --

In our opinion, there are "blind spots" in this school bus driver's field-of-view. Of greatest importance in this fatal collision is the "blind spot" near Test Cylinder position H that is due to improper front-right, crossover, convex and front-left, crossover, convex mirror adjustments. There are also "blind spots" near Test Cylinder positions J (between the driver's window and left-front bumper corner) and K (i.e., between the right-side exit door and the right-front bumper corner). There is also a "blind spot" near Test Cylinder position L between the right side of the bus and the test cylinder that is due both to improper front-right, side, convex mirror and right, outside, rearview, unit magnification mirror adjustment.

TRC/IU: 92-10, Task: 0085 Closeup R crossview mirror

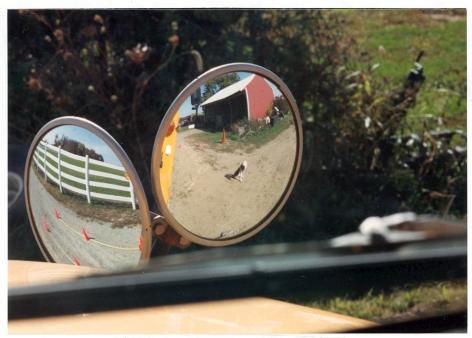
33 ---

TRC/IU: 92-10, Task: 0085 Closeup R side convex mirror

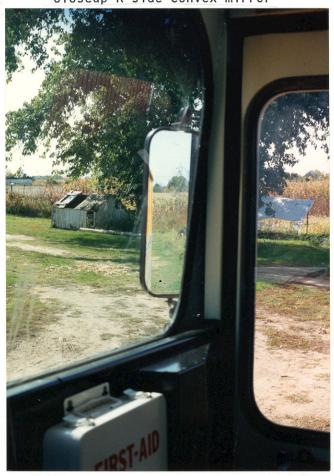
34 --

TRC/IU: 92-10, Task: 0085 R outside rearview mirror

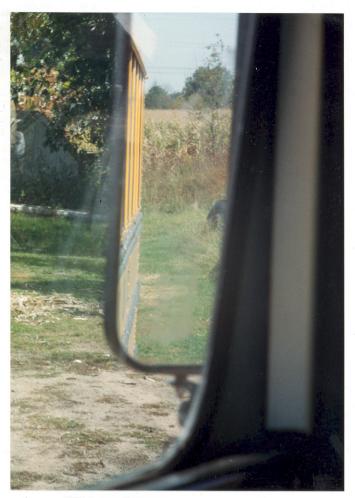
35 --

TRC/IU: 92-10, Task: 0085 Closeup R outside RV mirror

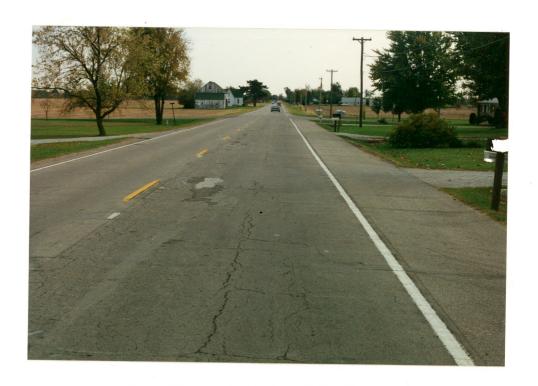
40 -- 1992

TRC/IU: 92-10, Task: 0085 Impact @ far side driveway

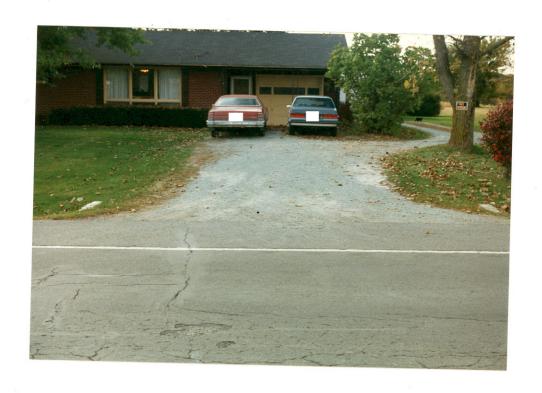
41 -- 1992

TRC/IU: 92-10, Task: 0085 Driveway & impact looking SW
